BLUE LATITUDE PRESS

Updates for Sea of Cortez, A Cruiser's Guidebook

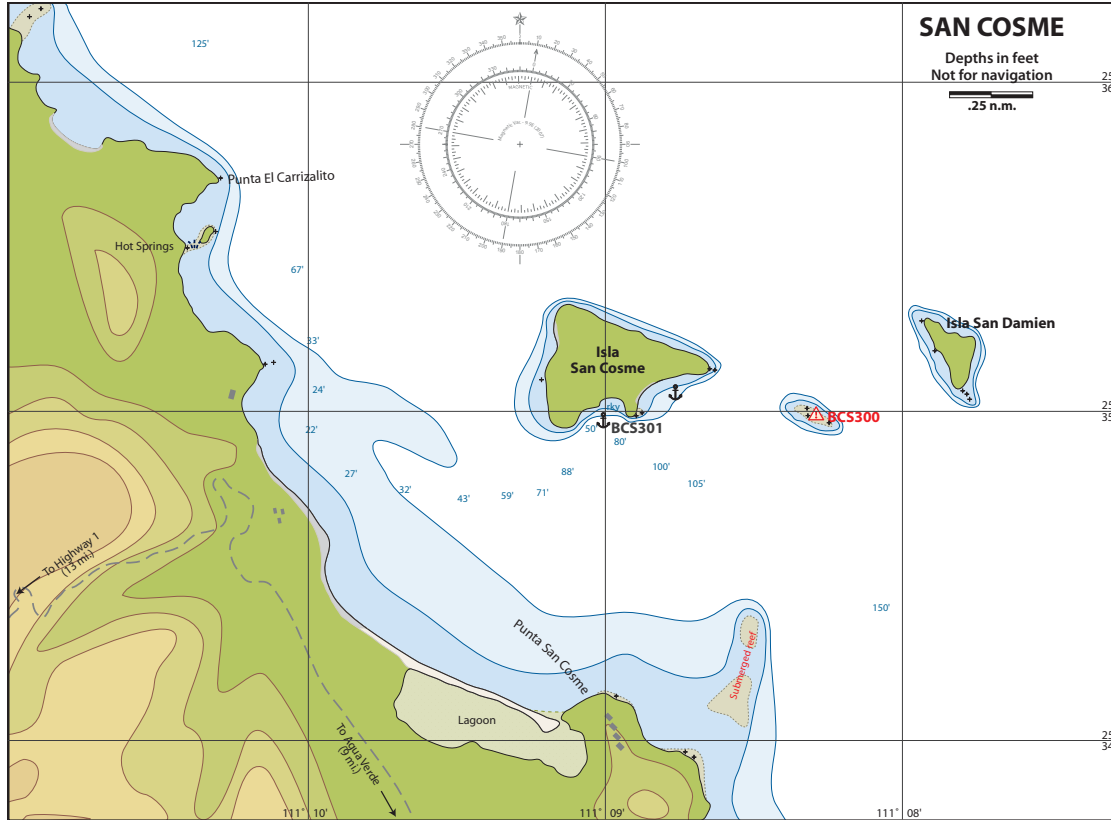
Pg. 132 - A revised chartlet is available for San Cosme (see attachment, page 3). Changes to the chartlet include the reef off Punta San Cosme, the hot springs and additional anchorage. The chartlet is also available online for downloading at www.exploringcortez.com and www.bluelatitudepress.com. San Cosme, like Bahía Agua Verde, can be affected by nighttime/early morning westerly winds coming down from the Sierra de la Giganta mountain range. These winds can be mild, moderate or occasionally strong in force and neither anchorage at Isla San Cosme provides protection from these winds. (Information courtesy of Terry Kennedy on s/v Manta) July 2008

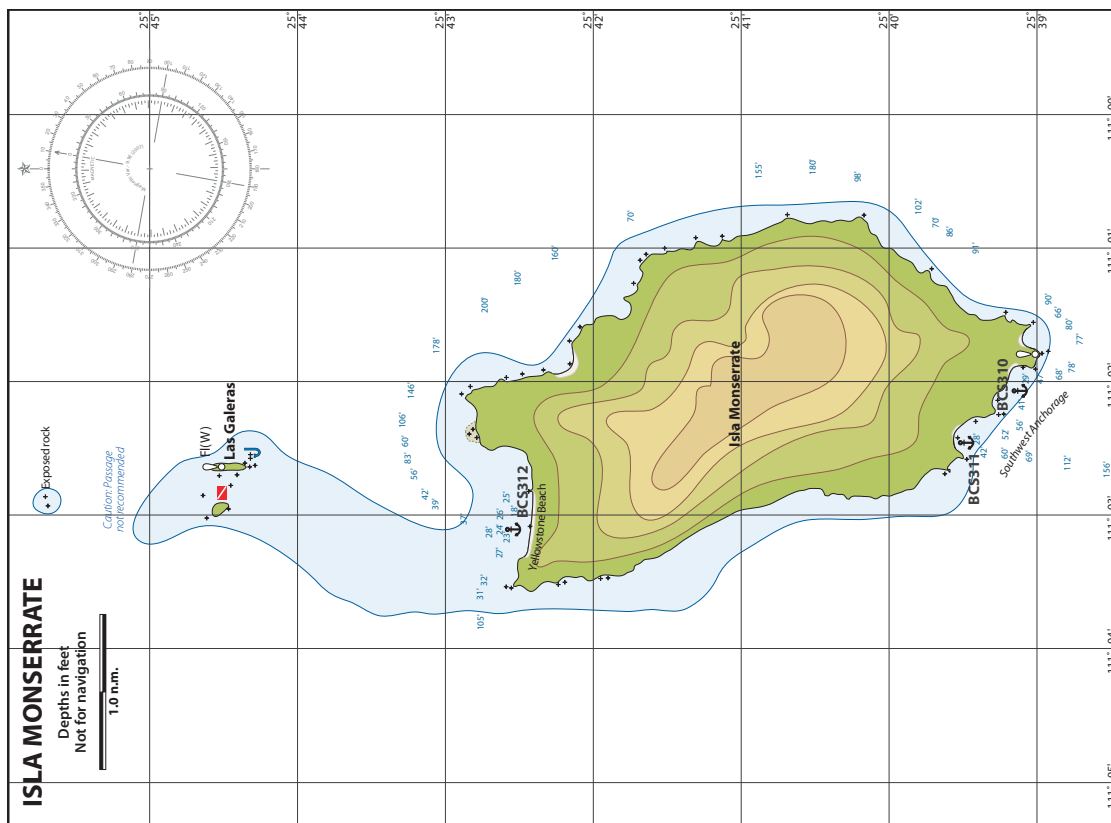
Pg. 134 - A revised chartlet is available for Isla Monserrate (see attachment, page 3). Changes to the chartlet include the shallow and rocky area surrounding Las Galeras. The area north of Las Galeras including the exposed rock has not been surveyed and is known to have shallow water and possible pinnacle rock(s). Passage through this area is not recommended. The chartlet is also available online for downloading at www.exploringcortez.com and www.bluelatitudepress.com. Isla Monserrate, like Bahía Agua Verde, can be affected by nighttime/early morning westerly winds coming down from the Sierra de la Giganta mountain range. These winds can be mild, moderate or occasionally strong in force and neither the north or south island anchorages provide protection from these winds. It has also been reported during north winds, that waves can build as they travel over the shallow area around Las Galeras, creating a dangerous lee shore at Yellowstone Beach on the north side of the island. (Information courtesy of Terry Kennedy on s/v Manta) July 2008
